Legionella Risk Assessment

1370760

Date of assessment: 20/09/2019

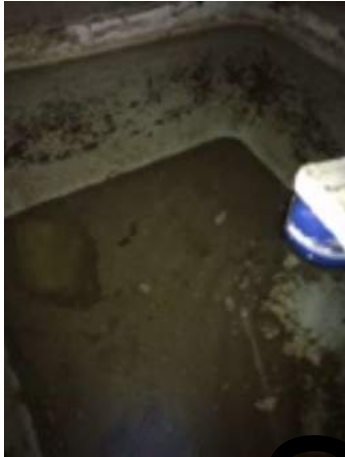
* The storage tank in the loft has no lid and has debris in it, until this is rectified I would recommend that the down stairs sink (water supplied direct from mains) is used for teeth cleaning as the upstairs tap is supplied from the loft tank. Although not a direct Legionella risk, there is a risk from rodents, birds and insects fouling the water.

Description: Tank internal

* Would recommend without delay that the cold water tank is cleaned and all debris removed, it is properly insulated with a secure lead also insulated, it may be prudent to replace the tank as the current one is in a poor state. Also that the hot water tank is fitted with a thermostat to correctly regulated the hot water temperature.

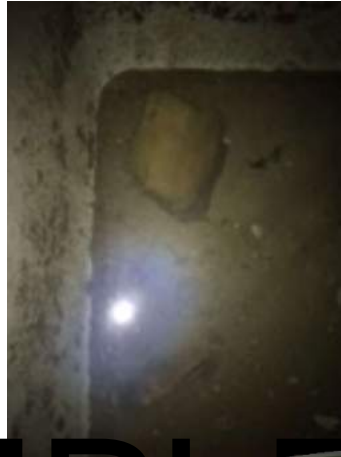
Description: Tank internal

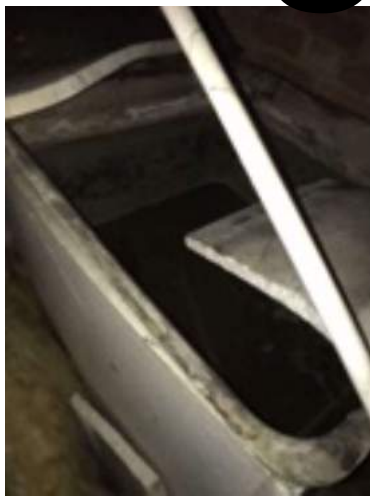
Description: Poor insulation

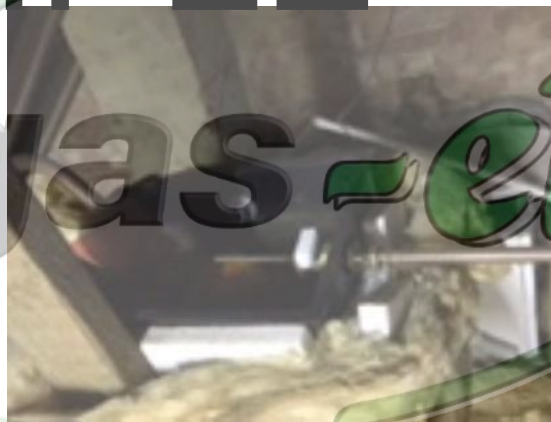
Description: Overall view
