# Landlords / Homeowner Gas Safety Record - G2

Cert. No: CT-1151359-1522708001

# Appliance Service Record

# Accompanying Photos

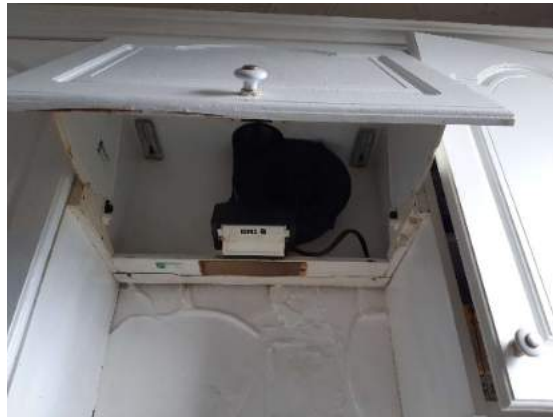
Description: Cooker hood filter panel missing.
