Home Services Report

Landlords / Homeowner Gas Safety Record - G2

Plumbing Condition Report

Central Heating Condition Report

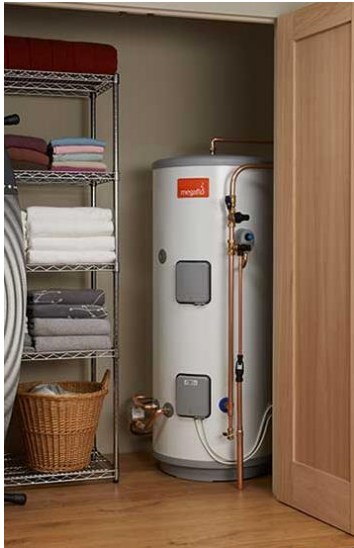
Hot water Storage

Item tested	Condition	Comments
Hot Water Storage	Fair	Foam lagged cylinder in airing cupboard and no problems found
Immersion operation & elements	Fair	Tested and working
Cold Water Storage Tank	Good	Found that the tanks in the loft area are lagged as is the loft. The tanks are plastic and in fair condition
Water flow rate (Main)	Fair	No problem found
Low pressure feed	Fair	The plumbing is working from low pressure from the tank in the loft
Stopcock	Good	Located under sink unit and working.
Outside tap	N/A	Garage has two taps and a hose is attached to the cold tap

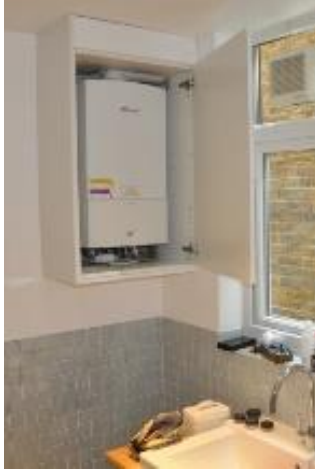
Boiler Details				
Make	Model	Approx. age (years)	Type	Location
Glow-Worm	Ultimate 50FF	20	Conventional Boiler	Bedroom airing cupboard

Item tested	Result	Comments
Boiler Condition	Fair	
Central heating pump	Fair	Located below the boiler. British gas pump and no fault found.
Heating control and timer	Fair	Randall 103 programmer in airing cupboard and working both on hot water and heating.
Room Thermostats	Good	Located in the lounge, British gas RS1. Good condition
Earth bonding to pipe work and boiler	N/A	
Motorised Valve(s)	Fair	Two 2 port honey well valves both working.
Feed/Expansion tank insulation	Fair	Lagged and fitted in the loft
Fuel Storage Tank and pipe work	N/A	
Discharge/Condense Pipe	N/A	
Drain off cock	Fair	Downstairs radiators have drain off valves.
TRV (Thermostatic Radiator Valves)	N/A	No TRVs on the radiators.

Radiators and pipework are probably over 30+ years old and need replacing in the near future along with the Boiler, as it is not very efficient.

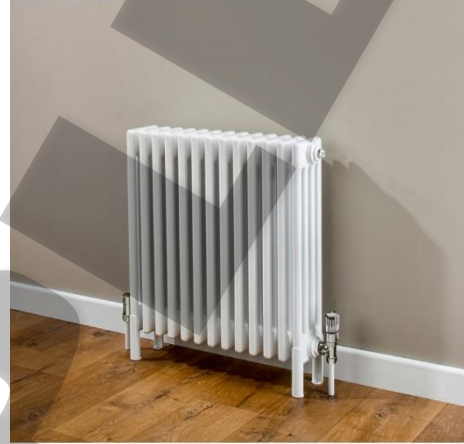
Radiator

Item tested	Result	Comments
Condition of radiators	Poor	Heating was tested and working. All the radiator valves are not working and are stuck open.
Number of radiators	9	
Radiators function correctly	Yes	
Radiators function efficiently	Yes
