Electrical Installation Condition Report - EICR

Landlord 5 year electrical safety test

22-May-2020

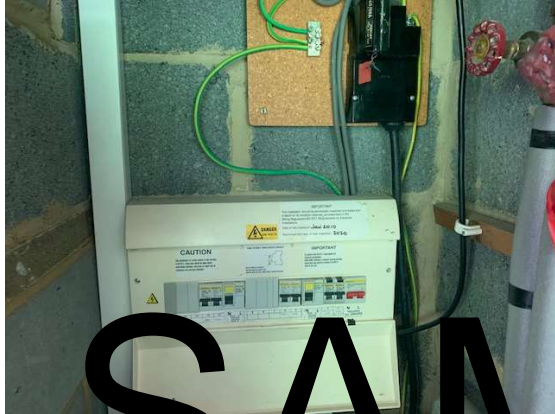
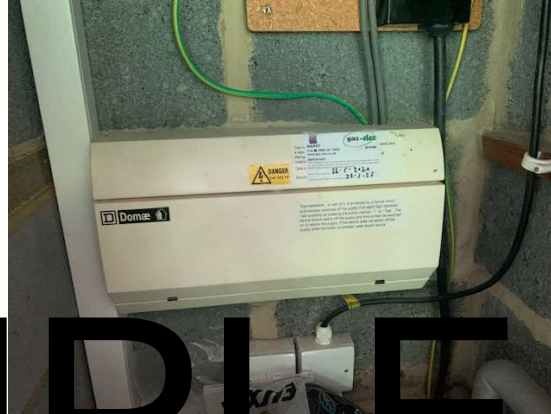
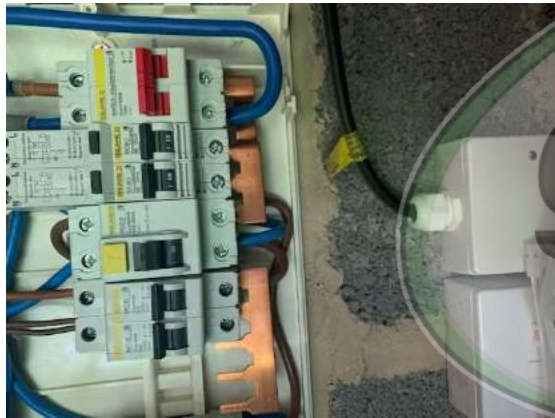
No.	OBSERVATION(S)	CLASSIFICATION CODE
1	4.18 RCD(s) provided for fault protection – includes RCBOs (411.4.204;411.5.2; 531.2) 4.19 RCD's provided for additional protection/requirements – includes RCBO's (411.3.3; 415.1) No RCD protection 3 & 4	C2
2	5.12 Provision of additional requirements for protection by RCD not exceeding 30mA - For all socket-outlets of rating 32 A or less, unless an exemption is permitted (411.3.3) - For supply to mobile equipment not exceeding 32A rating for use outdoors (411.3.3) - For cables concealed in walls at a depth of less than 50mm (522.6.202; 522.6.203) - For For cables concealed in walls/partitions containing metal parts regardless of depth (522.6.203)	C2
3	Circuit 3 & 4 no RCD protection 5.18 Condition of accessories including socket outlets, switches and joint boxes (651.2 (v)) Bathroom shaver light not functioning	C3

4.17	Protection against electromagnetic effects where cables enter consumer unit/distribution board/enclosures (521.5.1)	AC
4.18	RCD(s) provided for fault protection - includes RCBOs (411.4.204;411.5.2; 531.2)	C2

4.19	RCD's provided for additional protection/requirements - includes RCBO's (411.3.3; 415.1)	C2
4.20	Confirmation of identification that SPD is functional (651.4)	NA

Description: CONSUMER UNIT

To undertake required remedial works as shown as Code - C2,
Move MCB's circuit 3&4 to RCD protected side of Consumer Unit.
Cost of these works alone £130.00 + VAT

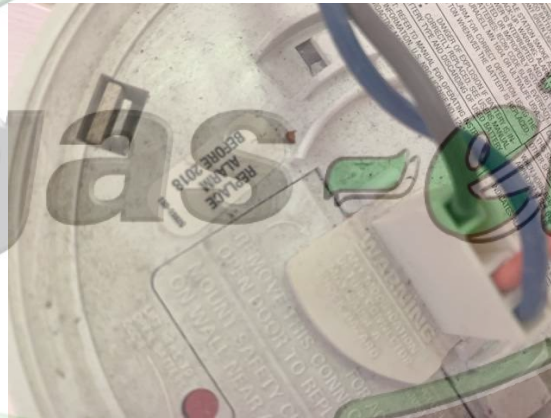
Hard wired smoke detector expired in 2018

Description: SMOKE DETECTOR

To undertake recommended remedial works as shown as Code - C3,
Supply and fit replacement bathroom sahaber light
Supply and fit hard wired smoke alarm

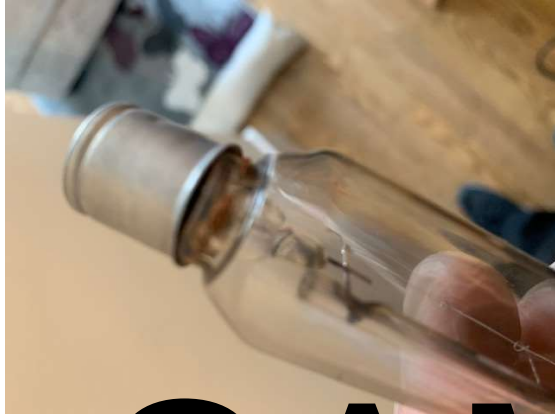
5.18	Condition of accessories including socket outlets, switches and joint boxes (651.2 (v))	C3
5.19	Suitability of accessories for external influences (512.2)	AC

Description: BATHROOM SHAVER LIGHT

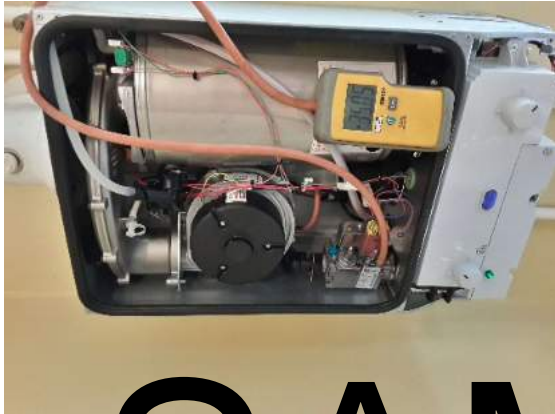
Item tested	Result	Comments
Boiler Condition	Good	
Central heating pump	N/A	Located in loft
Heating control and timer	Fair	Honeywell. Hot water not working
Room Thermostats	Fair	Honeywell
Earth bonding to pipework and boiler	N/A	
Motorised Valve(s)	Fair	Heating working
Feed/Expansion tank insulation	Good	Lagged and lid fitted
Fuel Storage Tank and pipe work	N/A	
Discharge/Condense Pipe	Good	
Drain off cock	Fair	Some rads have no drain off valves
TRV (Thermostatic Radiator Valves)	Fair	All working

Description: Boiler

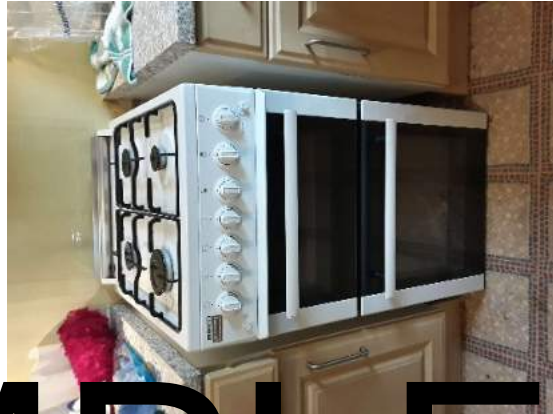
Description: Cooker

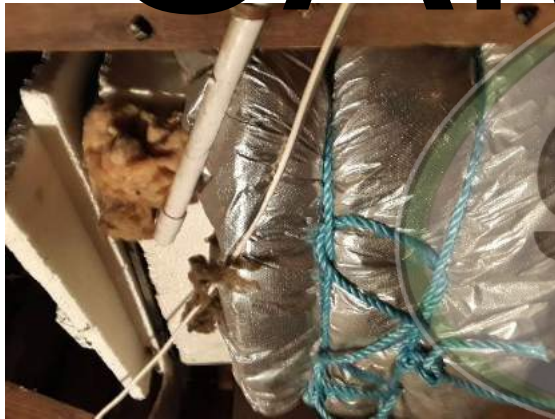
Item tested	Condition	Comments
Hot Water Storage	Fair	Located in the loft has a lagging jacket
Operation of immersion elements	Fair	Switch is located in hallway
Cold Water Storage Tank	Fair	Plastic tanks with lids and lagging jackets
Water flow rate Main.	Fair	Tank for hot water and bathroom Mains pressure cold water to part of the system
Low Pressure	Fair	
Stopcock		Located in a kitchen cupboard is working and good condition
Outside tap.	Fair	No non return valve fitted

Description: Loft

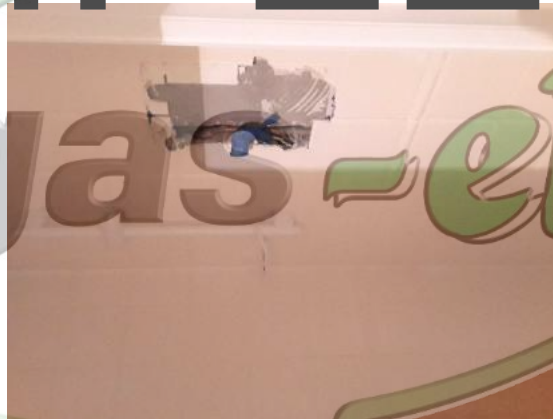
Item tested	Condition	Comments
Hot Water operates effectively	Fair	Some taps could do with replacing
Kitchen sink & plumbing	Fair	Taps and sink are good as is visible plumbing
Utility room & plumbing	N/A	
Washing machine etc. & plumbing	N/A	
Dishwasher & plumbing	N/A	
Ground floor WC & plumbing	Fair	The WC's and sink and bath are in good condition The taps in bathroom should be replaced
En suite other	N/A	
Family bath room & Plumbing	Fair	Taps in poor condition
Condition of baths & showers	Good	Electric shower has been removed Bath in fair condition

Description: Shower
